# **HAZARD ALERT**

## **Swing Yarder Guyline Failure**

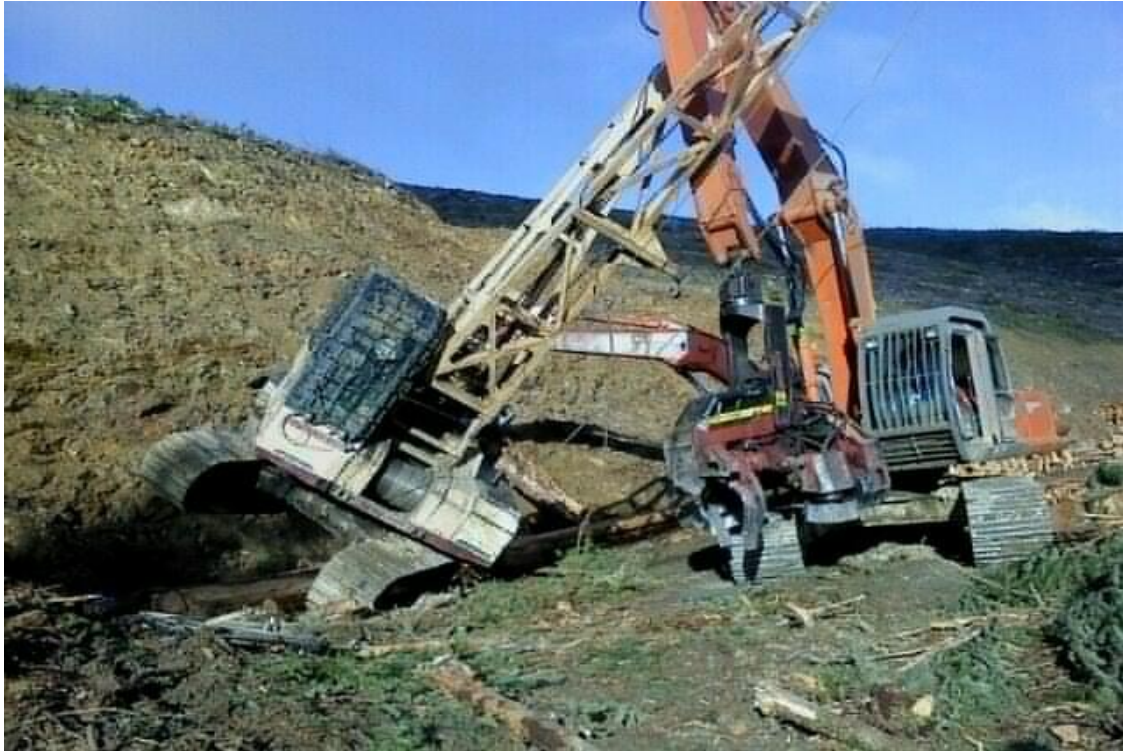
**Background:** A Swing Yarder operator escaped injury during inhaul when one guy line snapped and another extension failed when movement occurred at the “wrap and go back” stump anchors, triggering a catastrophic rigging failure, causing the swing yarder to lay over onto its side leaning against the excavator with a Waratah processing head.

- Ensure all guy line anchor stumps are sufficient size and correct height of solid wood above the notch,
- Ensure that guy ropes do not override if a “wrap and go back” stump anchoring system is employed,
- Careful planning of guy-line anchor stump at point of felling or plan skid size to allow for installation of dead men.
- Ensure a hauler log book is available to record all maintenance, age of ropes, guy line and extensions, this forms part of the evidence needed for tower certification & company requirements
- Guy lines should be checked daily by a competent person, and best practice would suggest this guyline check should be recorded.
