HAZARD ALERT

Beware around processing head danger areas

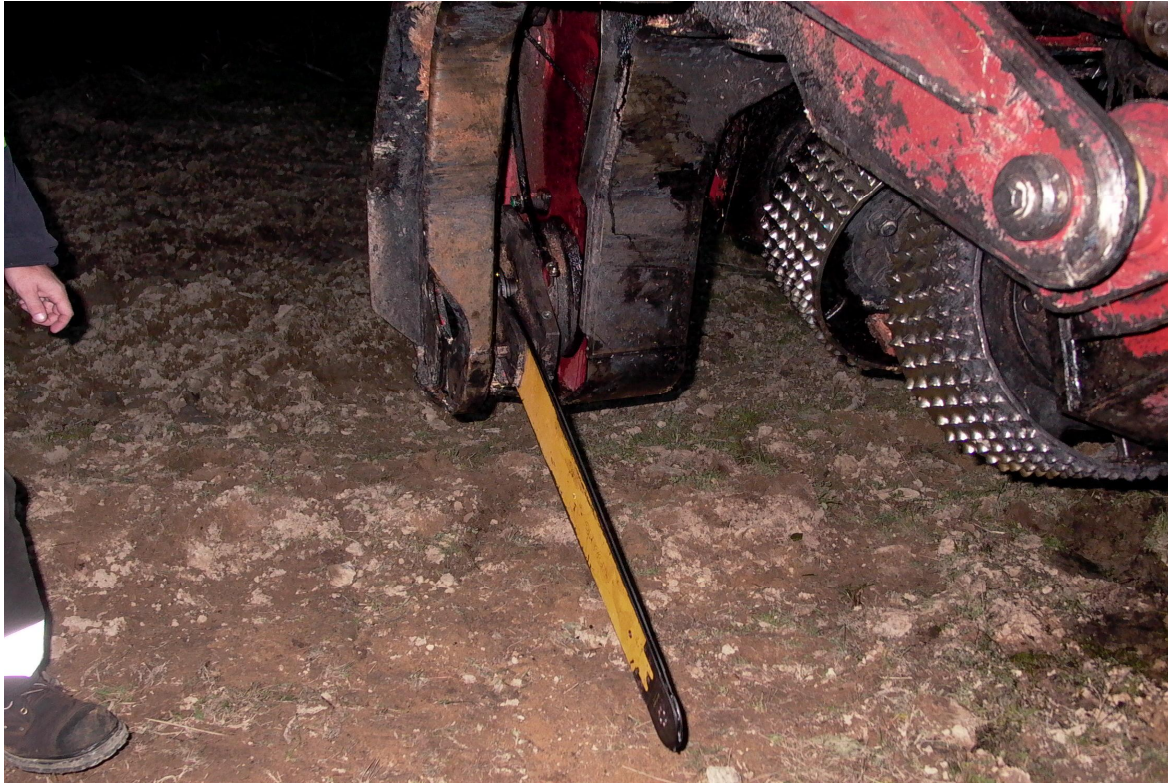
A senior machine operator had his left hand partially severed during fault finding maintenance, where log processing chainsaw bar oiler had stopped working; the harvest operator has maneuvered the machine from the cut over to the skid site, to investigate the oiler problem

The harvester operator had started the harvester, activated the chainsaw bar control, the chainsaw bar had cycled, The other machine operator was standing back approx three metres, he could not see the end of the oiler hose, so walked towards the log processor reached into make the hose more visible.

Unaware that 8-10 second into its cutting cycle, the (new model 624) Waratah's chainsaw bar automatically retracts, the operator came too close and was struck with considerable force on the wrist, which causing a severe laceration of the wrist and breaking both of the bones in the forearm

- Ensure machine is brought to zero energy state prior to any maintenance
- Follow Manufactures recommendation/warning labels on maintenance and fault finding
- Never place any part of your body within a danger area as outlined in maintenance manual
- If fellow work mates are helping with fault finding ensure they are aware of function cycles and computer quirks
